Manhole Inspection Summary

Manhole # S69Q__004MH

Location Address: **1419 Dundalk Ave.**

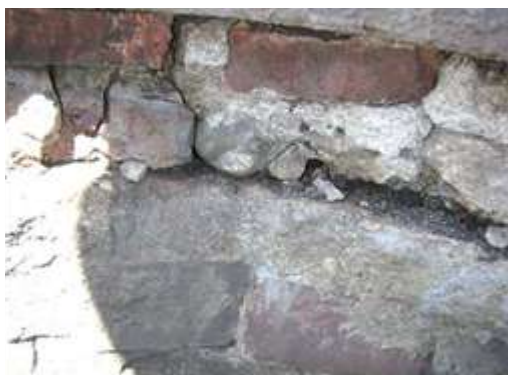
Defect 2

cracked brick at frame seal

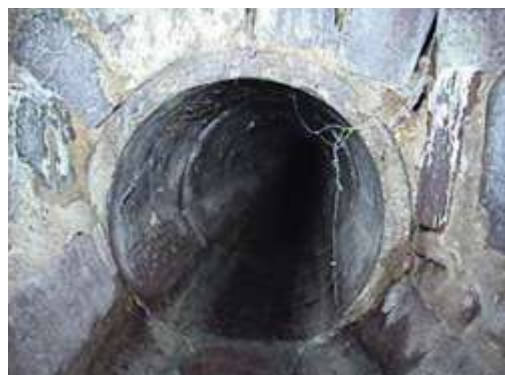
Defect 4

Crack in mortar or mortar is missing at 1:00 on incoming 9 O'clock

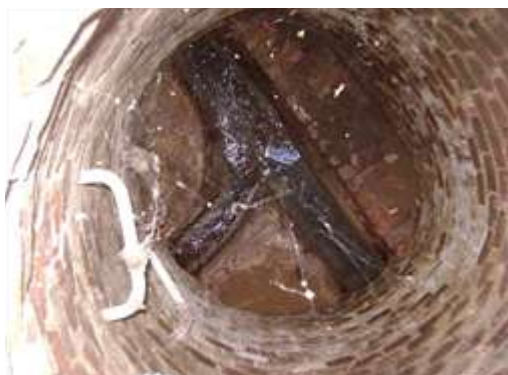
Defect 3

☒ **Evidence Of Surcharge** Depth: **2** (ft.) ☐ Active Surcharge Present

Surcharge evidence on step

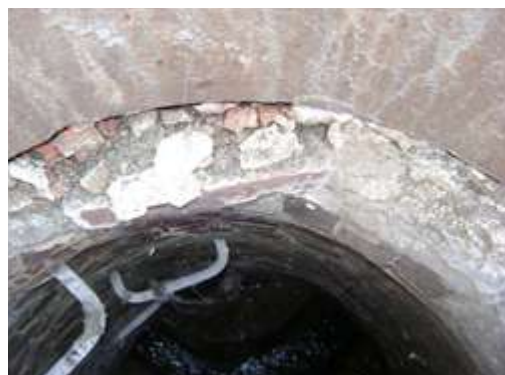
Defect 1

Condition: ☐ Sound ☐ Cracked ☐ Root Intrusion ☒ **Loose Brick** ☒ **Deteriorated**

Infiltration: ☐ None ☒ **Joint** ☐ Cracks ☒ **Mortar** ☐ Roots ☐ Wall

Loose bricks and mortar at frame seal

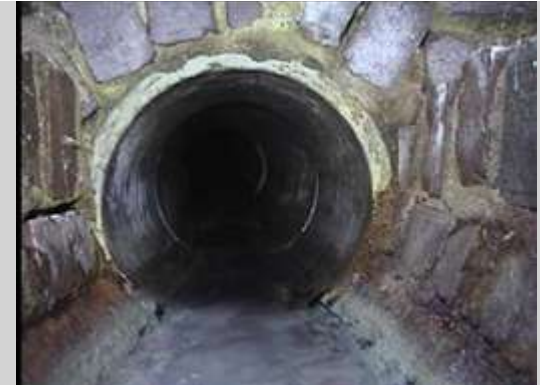
12 O'Clock Outflow

Pipe Height: **9.6** (in.) Rod and Bar (Angled)
Pipe Material: **Clay** ☐ Pipe Lined
Invert Depth: **8.67** (ft.) Flow Characteristics: **Slow**
Deposits: ☐ None ☐ Mud ☐ Sludge ☐ Debris ☒ **Grease**
Silt Depth: **0.125** (in.) Deposits Extent: **Light**
Infiltration: **None** Pipe Seal Cond: **Sound**

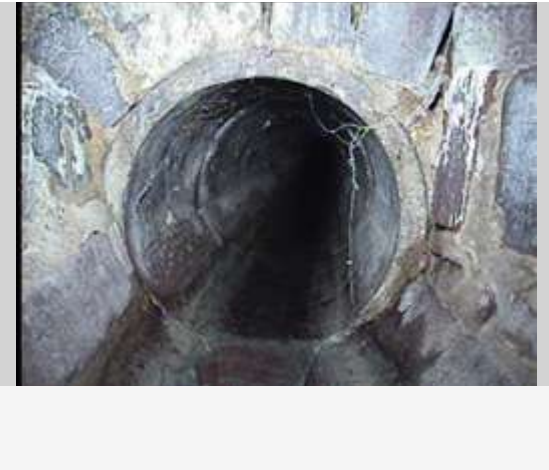
9 O'Clock Inflow

Deposits: ☐ None ☐ Mud ☐ Sludge ☐ Debris ☒ **Grease**

Silt Depth: **0.125** (in.) Deposits Extent: **Light**

Infiltration: **Evidence** Pipe Seal Cond: **Cracked**
